6.5 FURNITURE, FIXTURES, EQUIPMENT AND CONTENTS

6.5.2 BOOKCASES, SHELVING

6.5.2.1 BOOKSHELVES

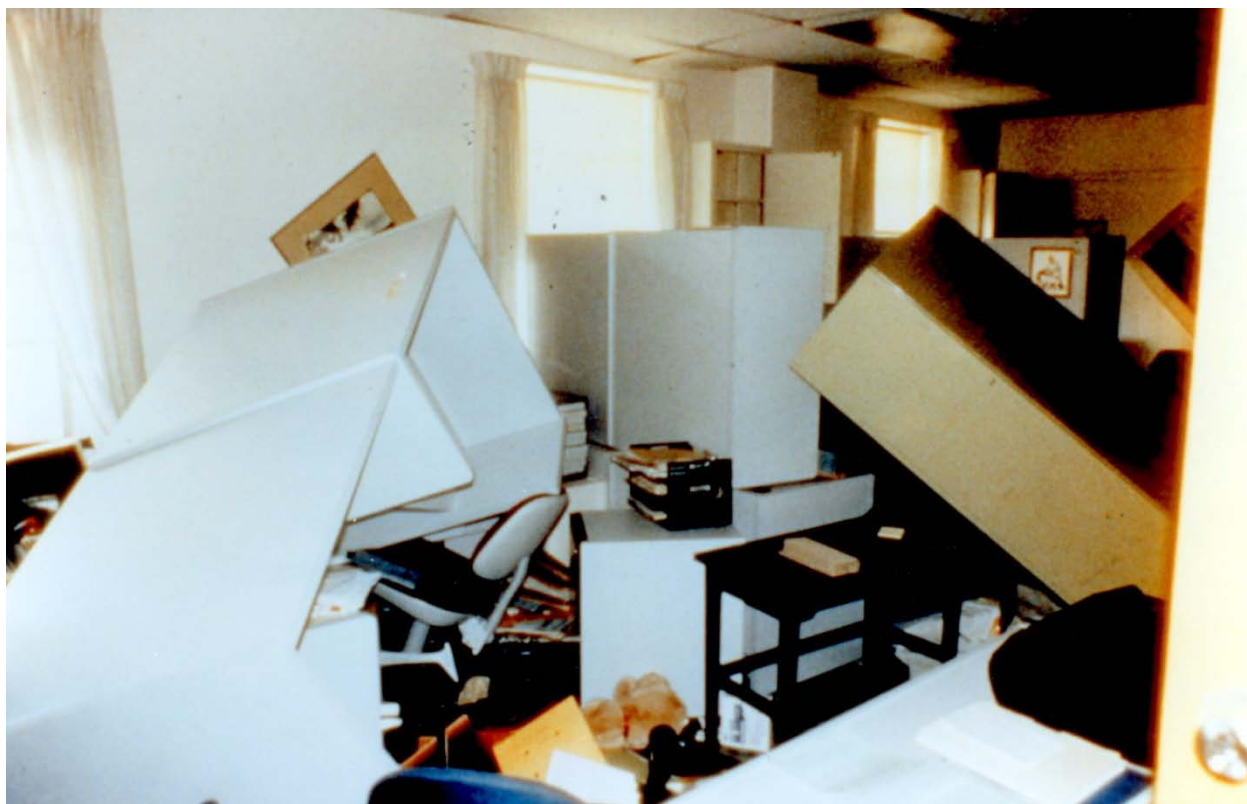
Figure 6.5.5.2-1 Damage to demountable partitions at the Veterans Administration Medical Center in Sepulveda as a result of the 1994 magnitude-6.7 Northridge Earthquake (Photo courtesy of James O. Malley).

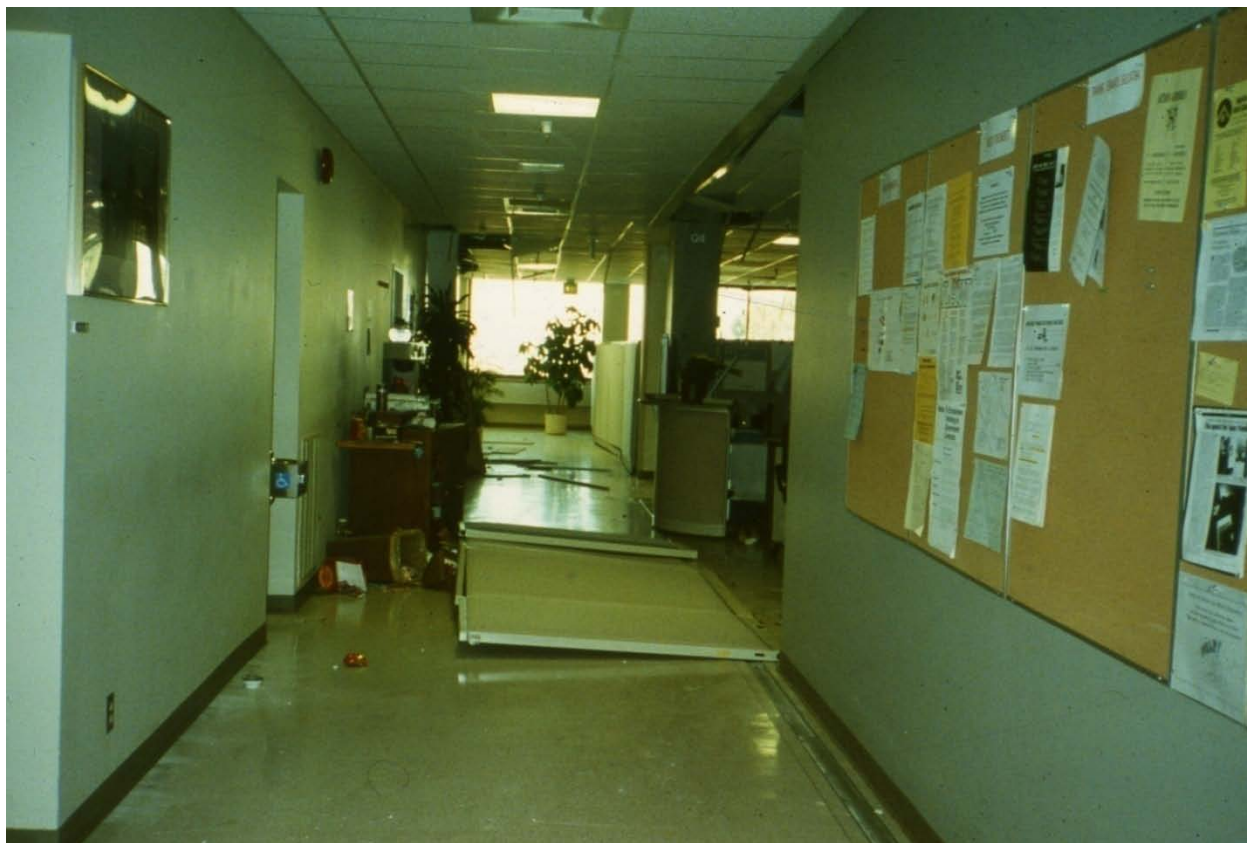
Figure 6.5.5.2-2 Damage to unbraced demountable partition in Silicon Valley office building in the 1989 magnitude-6.9 Loma Prieta Earthquake (Photo courtesy of Maryann Phipps, Estructure).

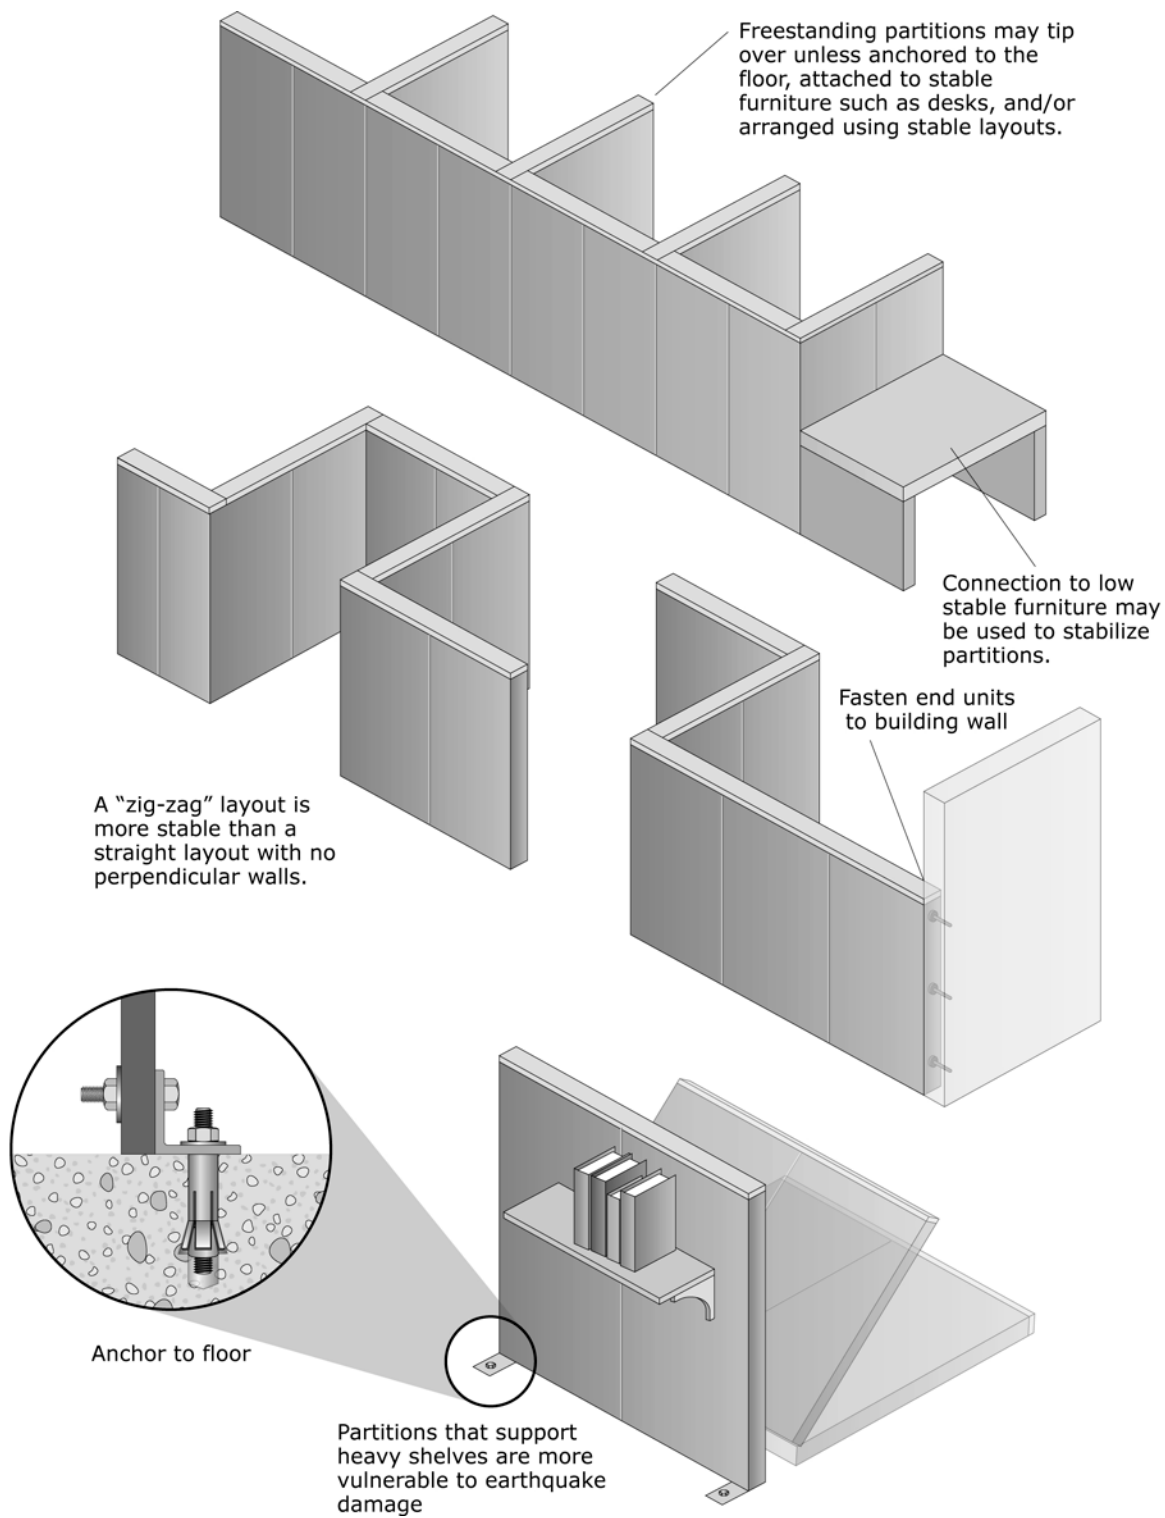
Figure 6.5.5.2-3 Demountable partitions (NE).

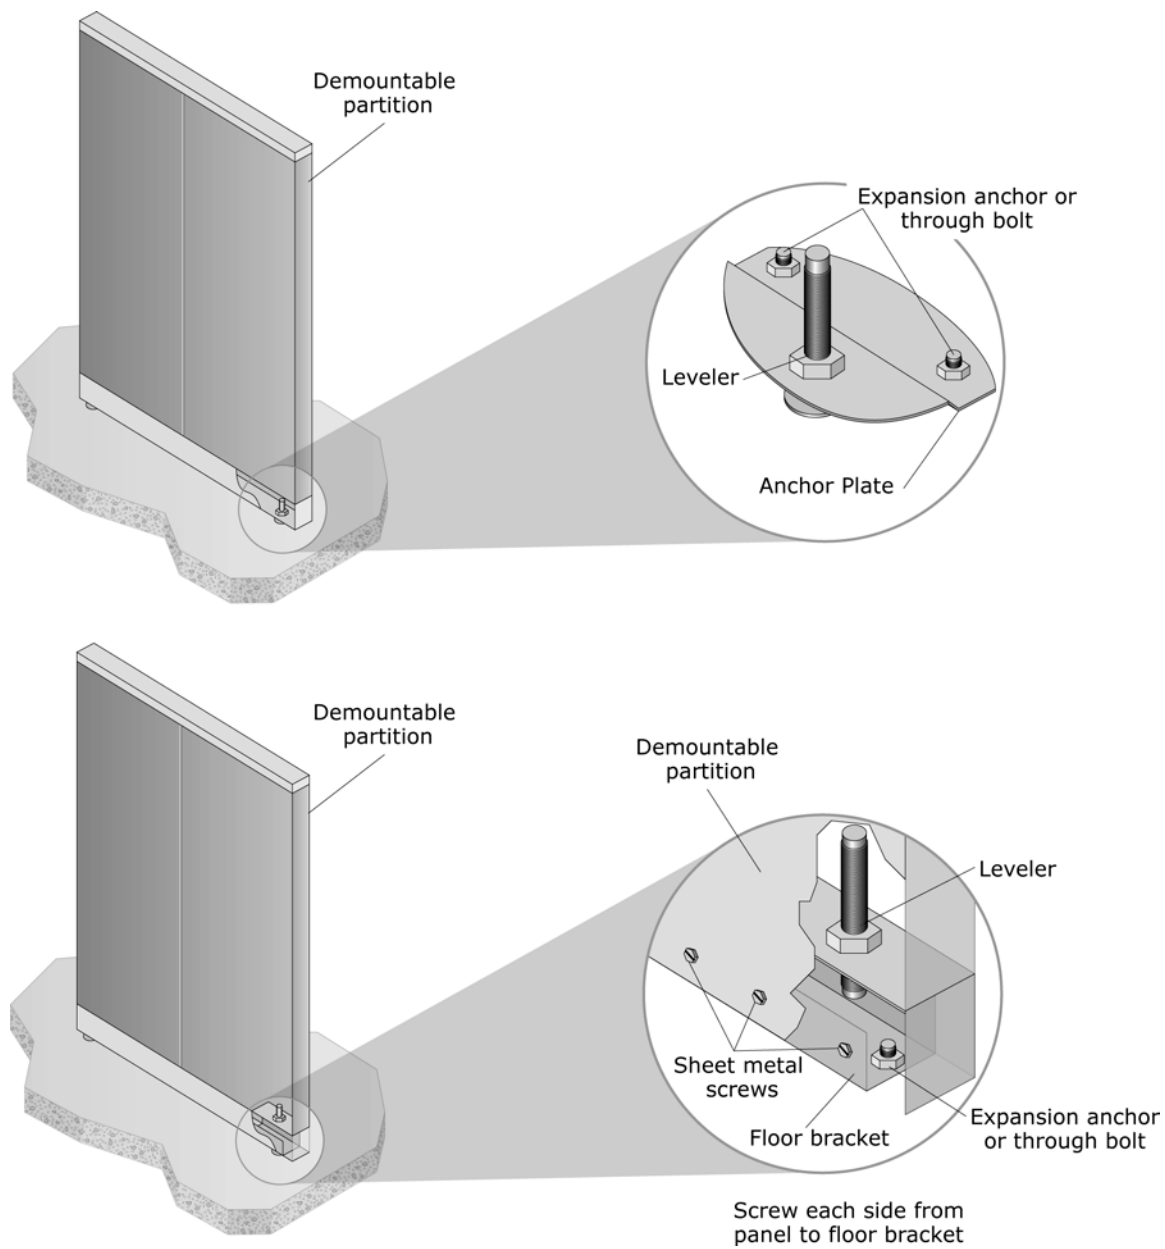
Figure 6.5.5.2-4 Demountable partition details (NE).

- Check the internet for demountable partitions with seismic rated capacity; some of these have been shake table tested and have improved seismic detailing.
- Panel manufacturers typically have guidelines for acceptable panel configurations for use in earthquake prone areas. Shorter runs of panels with panels at 90 degrees to one another provide favorable conditions for earthquake resistance. Panel anchorage at the base and interconnectivity between panels is also needed for reliable performance. Where panels are not stabilized by return panels, or where panels are tall, bracing at the tops of the panels, up to the structural framing, may be required. Anchorage to the floor slab is another alternative as shown in Figure 6.5.5.2-4.

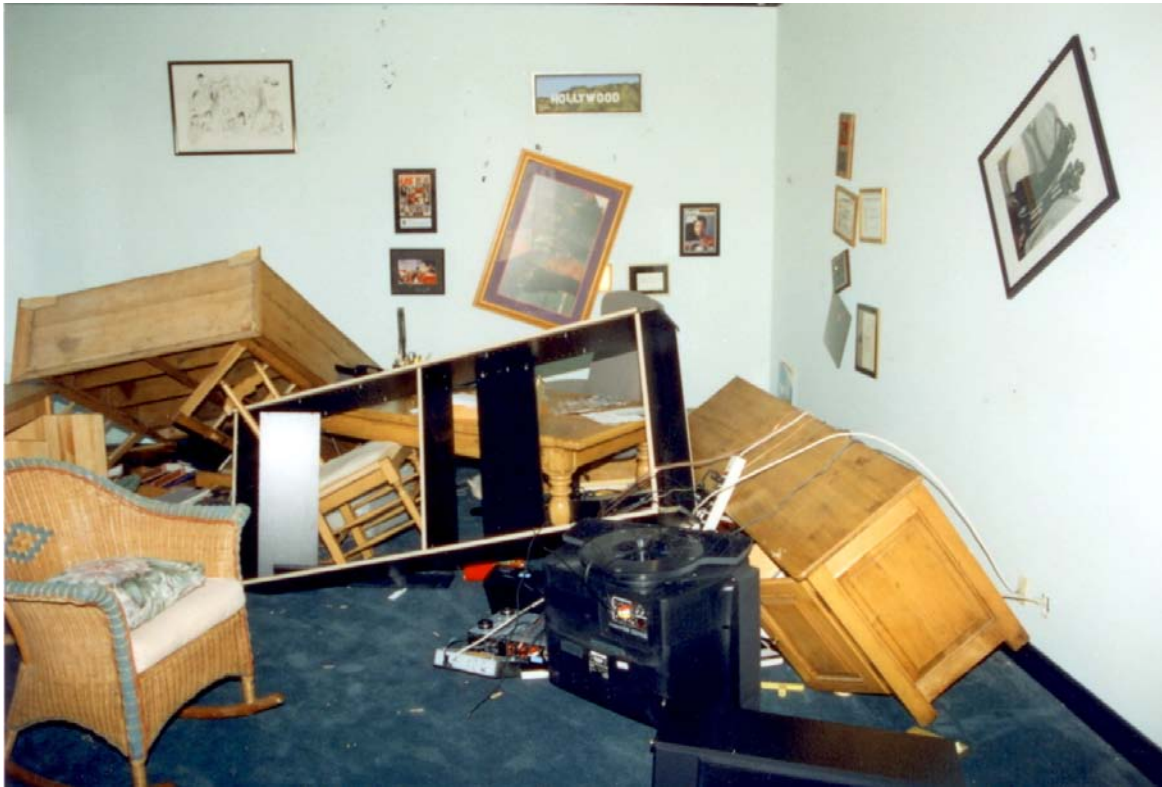
Figure 6.5.5.3-1 Residential damage in the 1994 magnitude-6.7 Northridge Earthquake (Photo courtesy of Wiss, Janney, Elstner Associates).

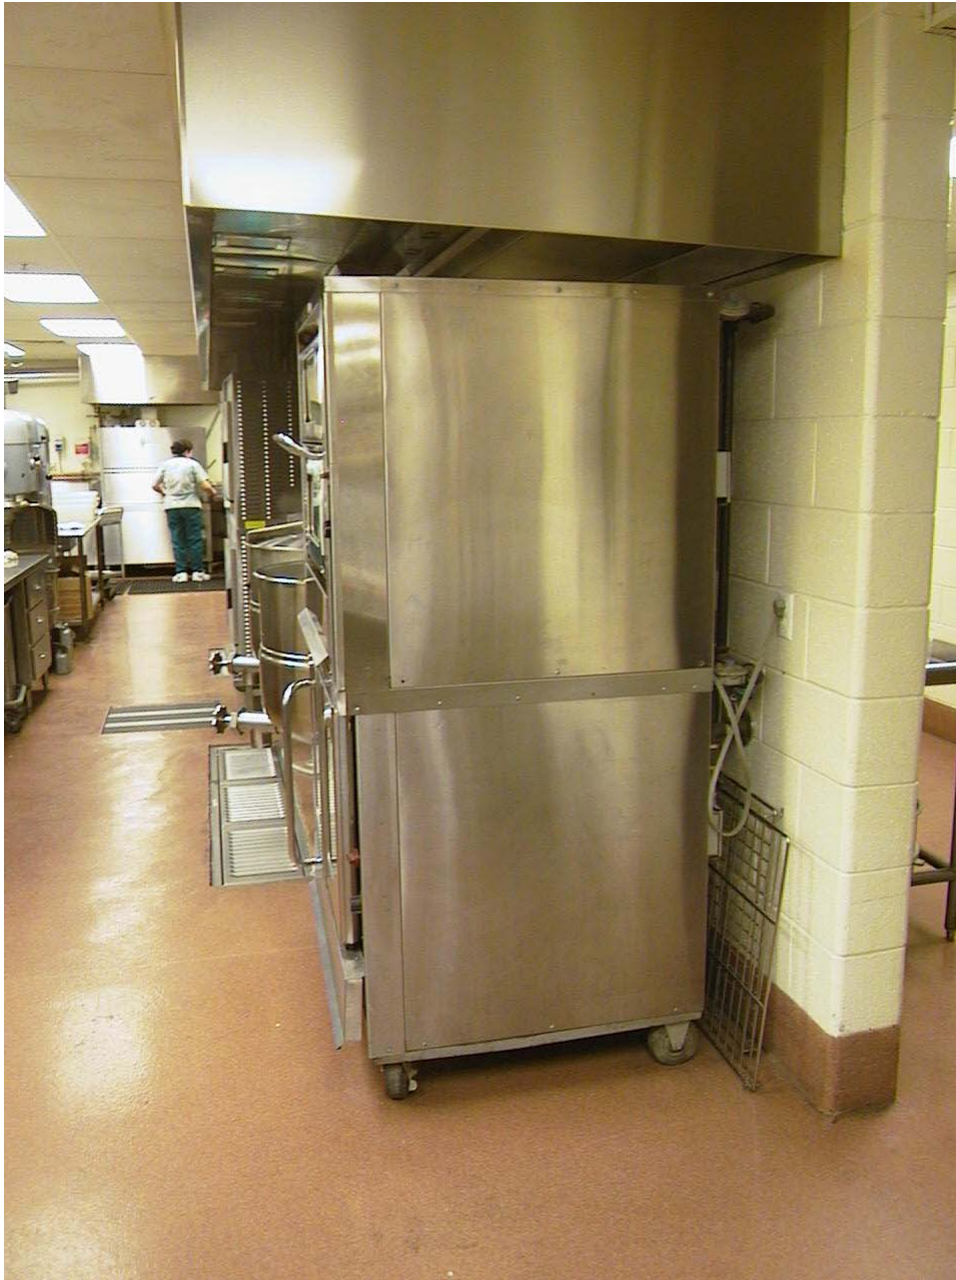
Figure 6.5.5.3-2 Existing condition: Unrestrained kitchen equipment (Photo courtesy of EQE for the Salt Lake City School District).

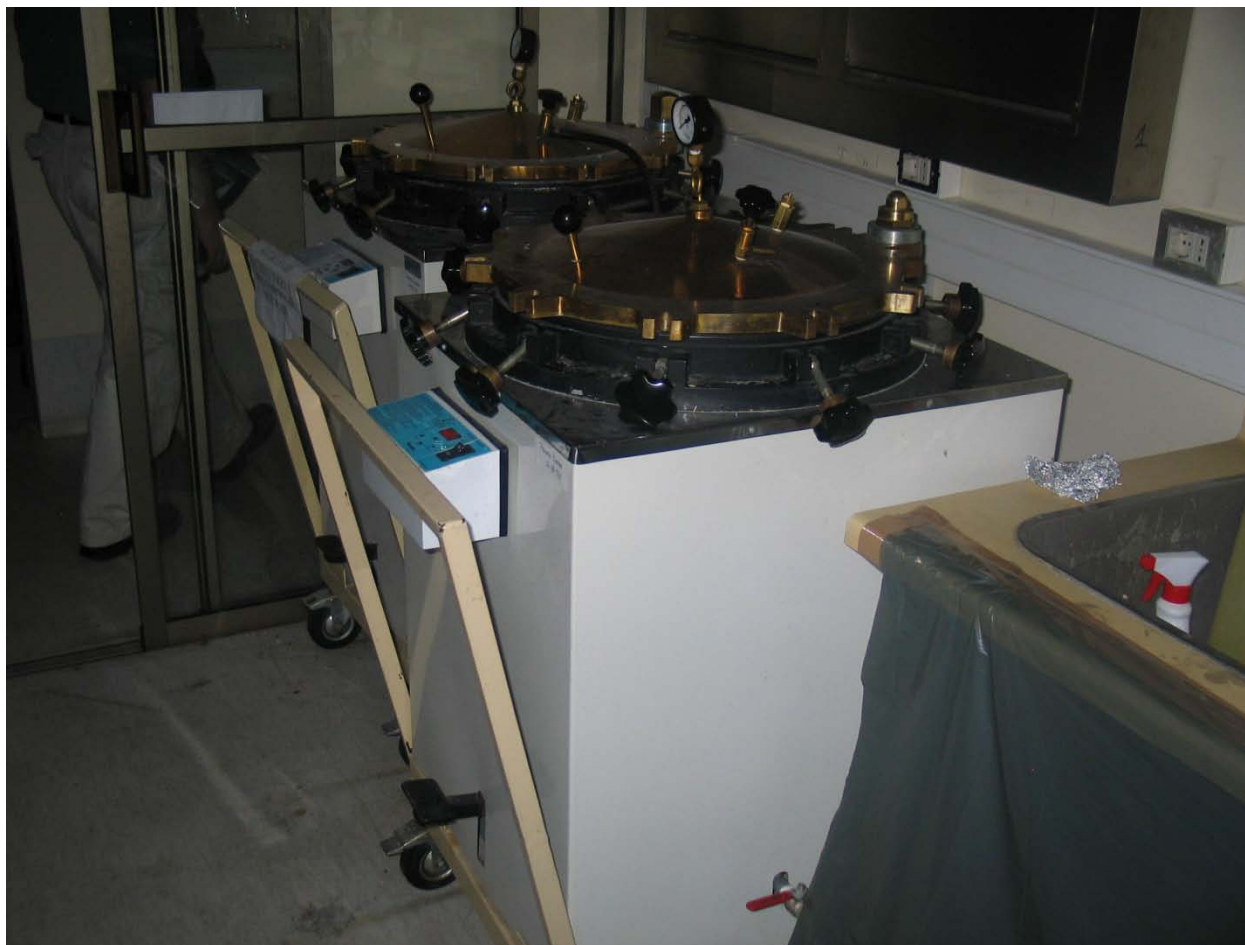
Figure 6.5.5.3-3 Equipment on wheels did well during the 2010 magnitude-8.8 Chile Earthquake; there were no reported injuries or examples of overturning related to equipment mounted on wheels. Centrifuges on wheels shown in photo (Photo and information courtesy of Bill Holmes, Rutherford & Chekene).

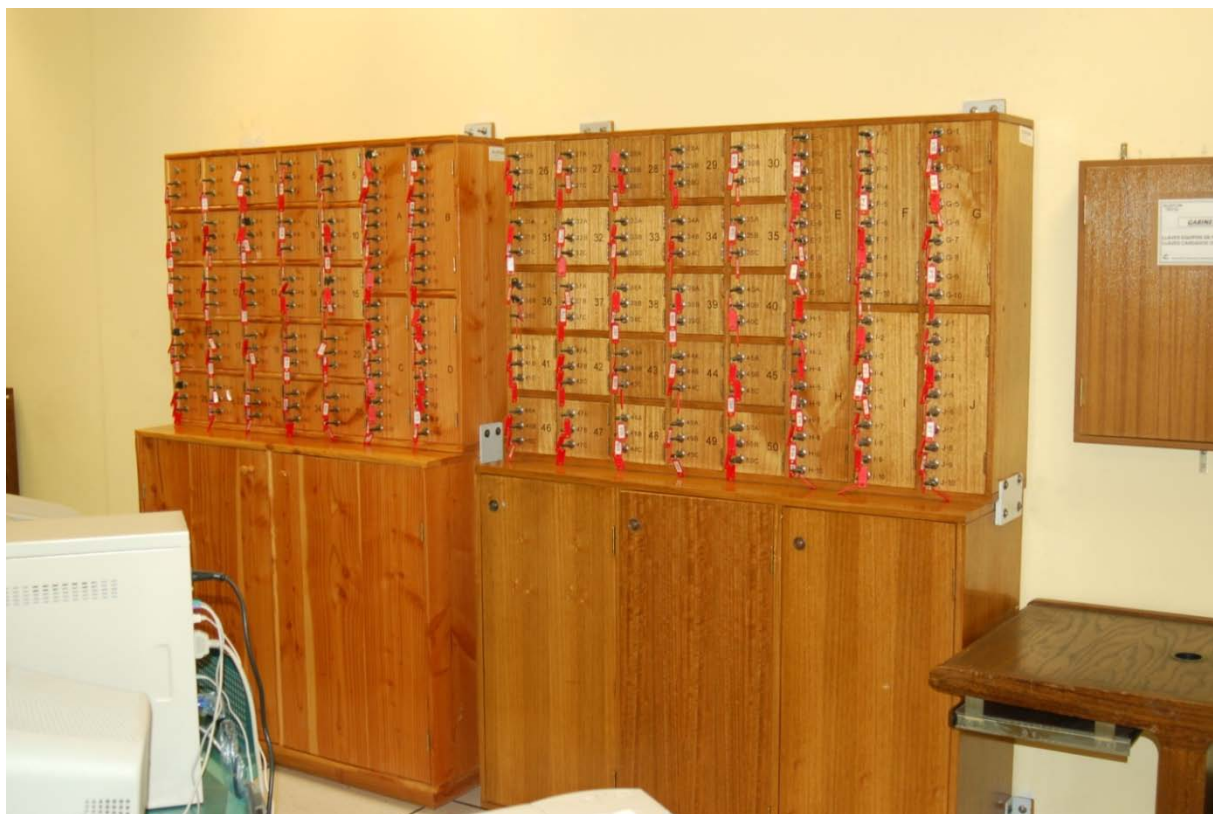
Figure 6.5.5.3-4 Anchored wood key cabinets in industrial plant control room; note top and bottom units anchored together and both anchored to wall (Photo courtesy of Eduardo Fierro, BFP Engineers).

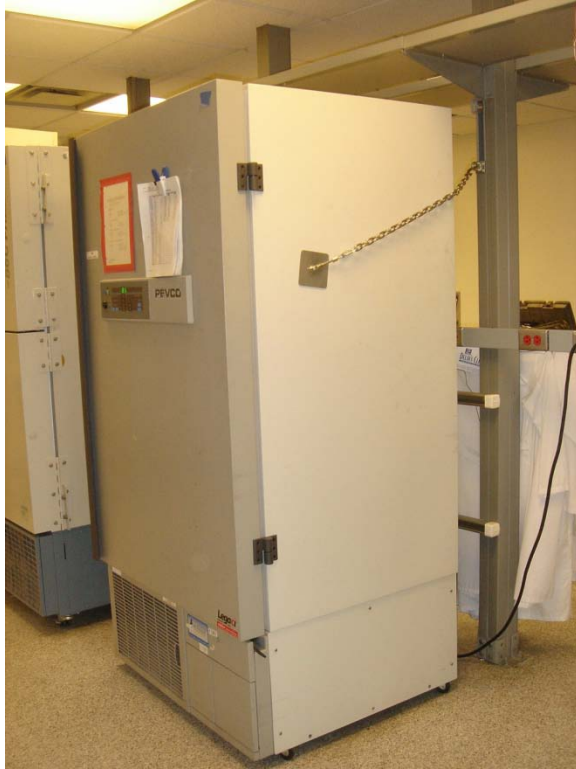
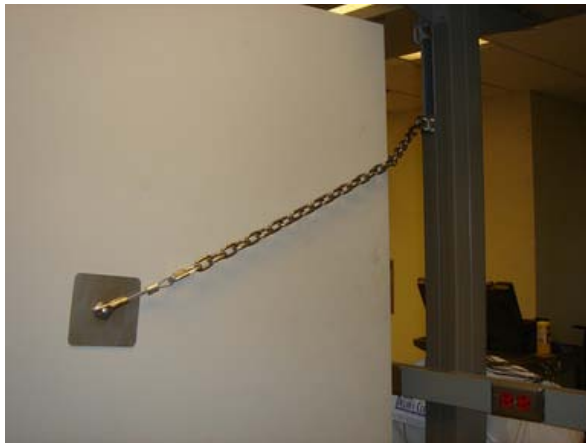
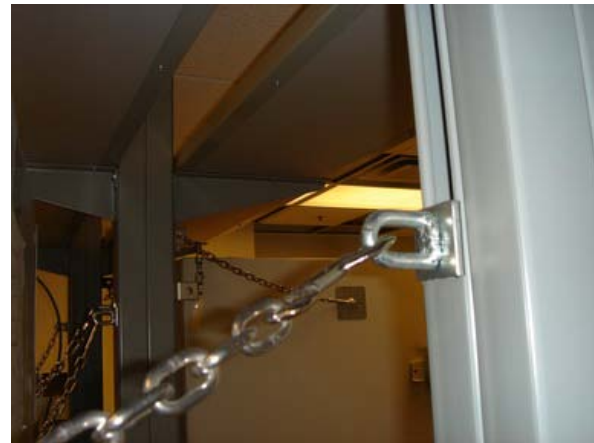
Figure 6.5.5.3-5 Typical tethering details for kitchen equipment and vending machines. Tether provided on both sides of equipment and does not penetrate the equipment housing (Photos courtesy of Maryann Phipps, Estructure).
